MITIGATING CORROSION UNDER INSULATION AND SUPPORTING THE LONGEVITY OF INDUSTRIAL PIPE INSULATING SYSTEMS

EXECUTIVE SUMMARY

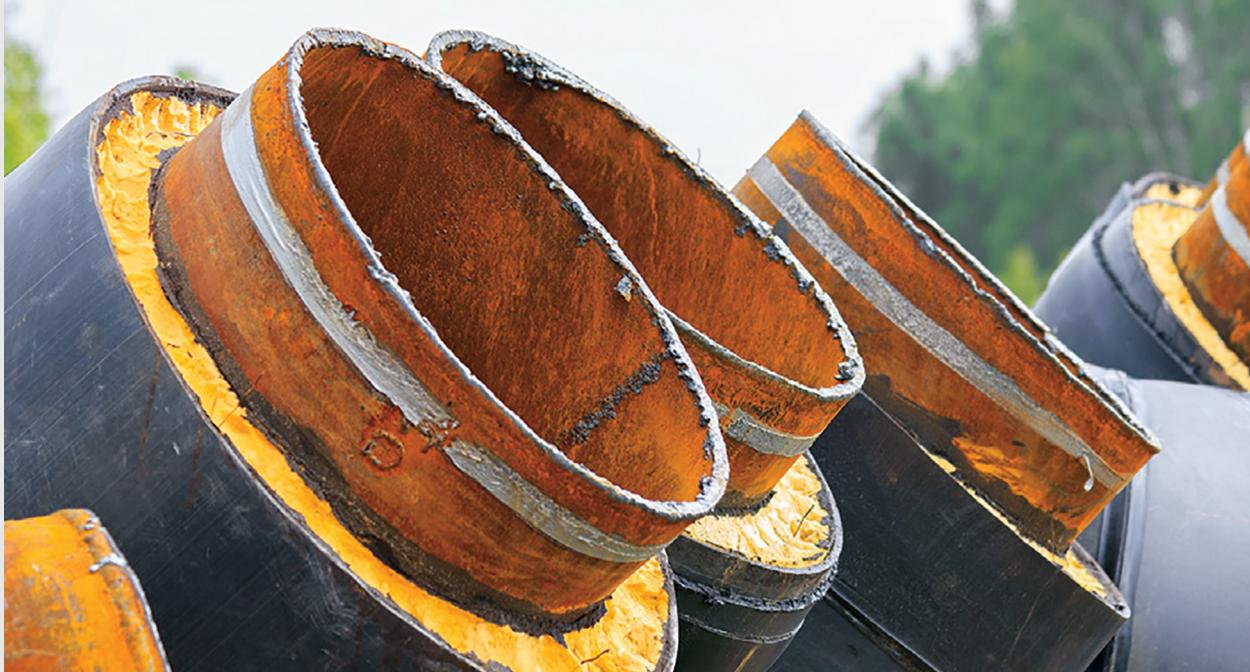
Figure 1 – CUI develops when moisture penetrates insulation or remains in contact with metal piping.

CUI occurs naturally when moisture penetrates an insulated system and oxygen in the water reacts with the steel pipe, causing it to degrade. High temperatures and the presence of dissolved minerals, such as chloride, in the moisture can accelerate the rate of corrosion. The danger zone for corrosion is 25°F to 350°F (-4°C to 177°C), so even pipes operating at the boiling point of water (212°F/100°C) and above may not be hot enough to evaporate moisture that permeates the insulation. This means that permeable insulation can become saturated over time, allowing moisture to stay in constant contact with the pipe surface.

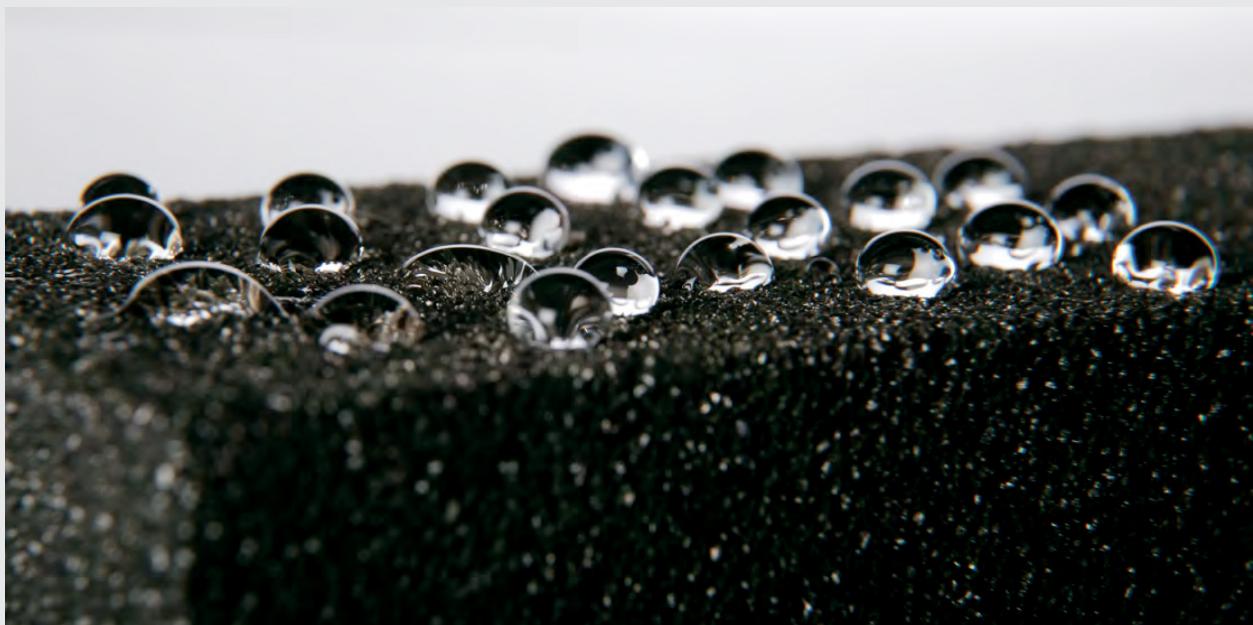
Figure 4 – Cellular glass insulation is made up of multiple closed-cell glass beads, making it impermeable and non-absorbent.

An insulation system's design and the type of insulating material specified can help protect against the development of CUI. Using an impermeable insulation, like FOAMGLAS® cellular glass insulation, helps prevent moisture from reaching covered pipes. Cellular glass is impermeable to water, either as a liquid or a gas, and is non-absorbent as demonstrated by ASTM C552 – Standard Specification for Cellular Glass Thermal Insulation testing.³ Cellular glass is resistant to most industrial reagents, is non-corrosive, non-combustible and fire-resistant and has a high compressive strength, plus it does not support the growth of mold or bacteria.

Beyond longstanding thermal performance, cellular glass offers other benefits for industrial pipes. The closed-cell insulation remains dimensionally stable through a range of temperature and humidity conditions. During shifts in temperature, cellular glass insulation has a coefficient of expansion similar to carbon or stainless-steel piping. This allows it to expand and contract with pipes and prevents the formation of gaps in the insulation when pipe size changes from fluctuating temperatures.

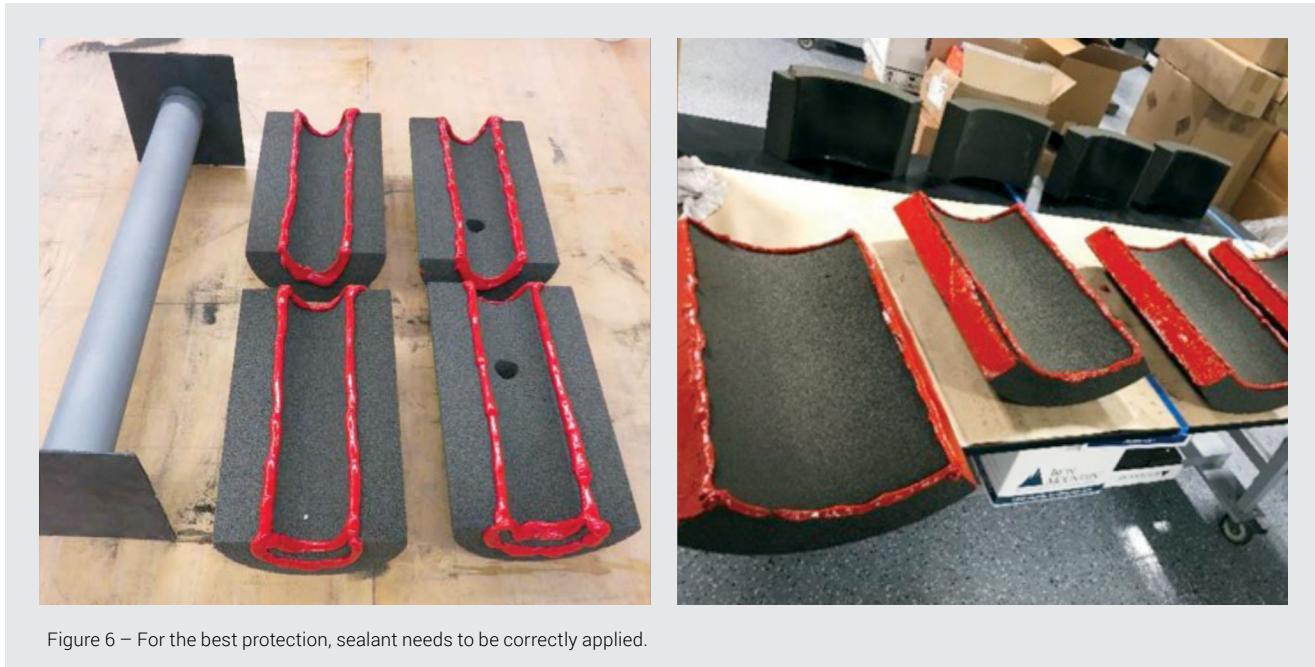
Figure 6 – For the best protection, sealant needs to be correctly applied.

PITTSEAL® Hi-Temp LV RTV is a low-viscosity sealant that performs across a wide temperature range, from -238°F (-150°C) to 450°F (232°C). When applied on the inner edge of the insulation bore, it provides a full-cover joint seal for both longitudinal and butt joints. This application method creates segmented sections for each piece of insulation added, which isolates the segments. This compartmentalization helps defend the entire system from moisture intrusion and reduces the potential for any errant moisture that does enter the system – such as following physical damage or when a section of insulation is removed for maintenance – to move to other areas of the pipe.

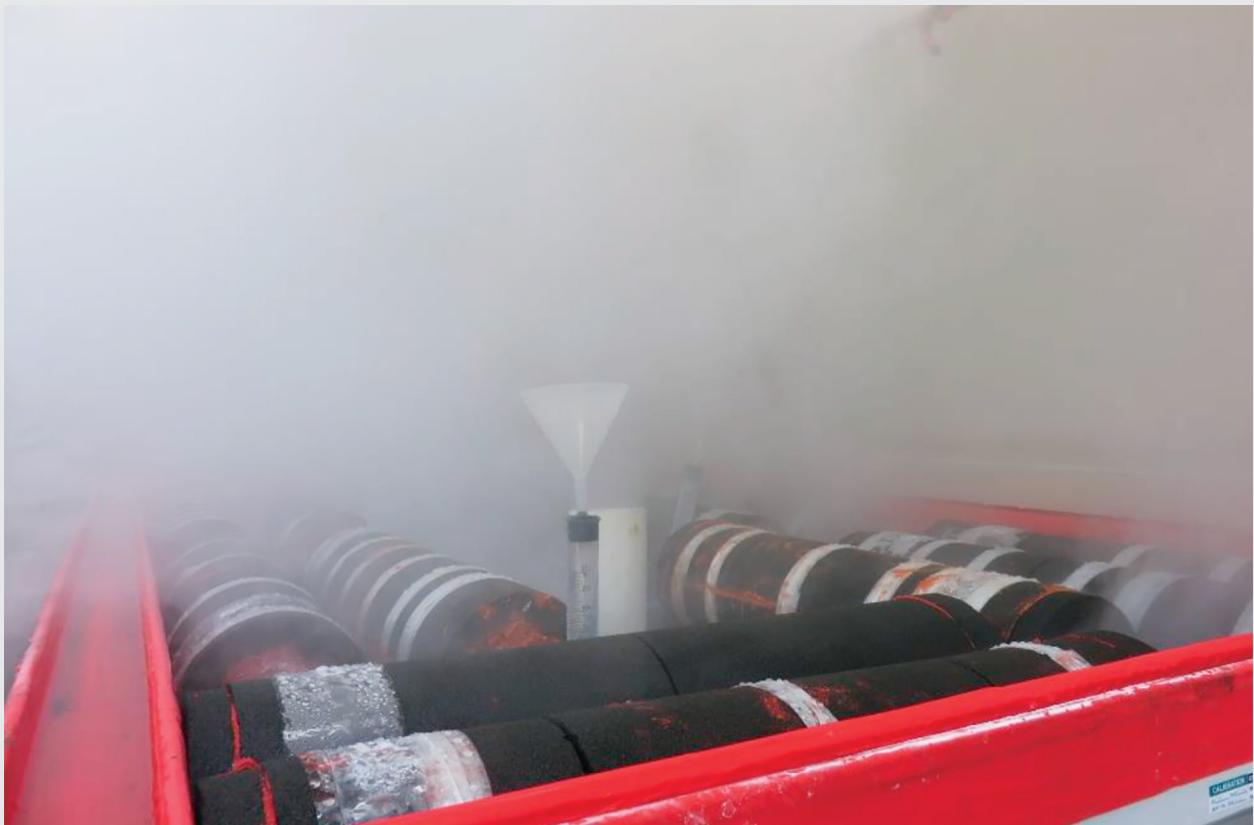
Figure 7 – Insulating systems were examined for the protection they provided against corrosive elements in a harsh environment.

To demonstrate insulation function, pipes of two different diameters – 16" (40.64cm) and 2" (5.08cm) – were insulated with cellular glass insulation and a neutral-cure sealant. The sealed pipe segments were then exposed to a modified ASTM B117 test – Standard Practice for Operating Salt Spray (Fog) Apparatus. The pipes were situated in a corrosion chamber for 28 days, where they faced either a temperature of 70°F (21°C) and a rain solution with 5% salt applied for 1 minute every 20 minutes, or a temperature of 95°F (35°C) with a constant fog of 5% salt and a rain solution with 5% salt sprayed once a minute every 20 minutes. Non-insulated pipes were exposed to the same conditions.

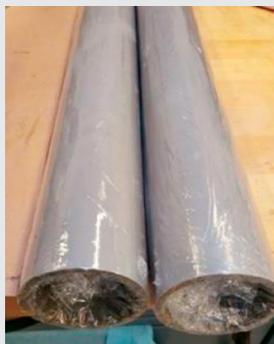
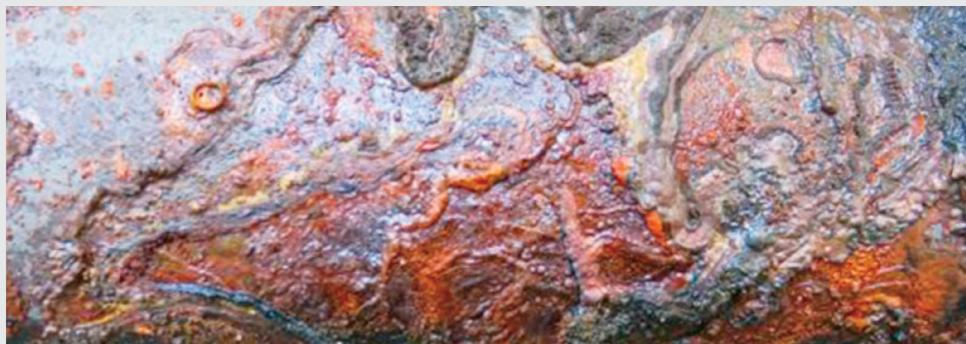
Figure 8 – Cellular glass insulation protected pipes from damage in a corrosive atmosphere; non-insulated pipes showed significant damage following the test's completion.

At the end of the testing period, the insulation was removed and the protected pipes were inspected and compared to non-insulated pipes. No rust was found on any of the insulated pipes. The unprotected pipes displayed significant exterior damage. This demonstration showed the sealed system's ability to help protect pipes from harsh environments and corrosive elements.

Sample ID			Notes
Rain Only Sealed System 16" Pipe			No rust
Rain + Fog Sealed System 16" Pipe			No rust
Rain Only Sealed System 2" Pipe			No rust
