# EXPERIMENTATION ON THE EFFECTIVENESS OF POOL FIRE SUPPRESSANT FOR LNG POOL FIRES

In February 2025, Owens Corning conducted a series of tests to evaluate the effectiveness of the FOAMGLAS® Pool Fire Suppression™ (PFS) Gen 2 system on reducing the burn rate, flame length, and thermal heat flux of a medium-sized LNG pool fire. Testing took place during the week of February 17, 2025, at the Texas A&M Engineering Extension Service's (TEEX) Brayton Fire Training Field. Texas A&M's Engineering Experiment Station (TEES) was enlisted to support instrumentation and data collection, while Blue Engineering and Consulting assisted with test design and data analysis.

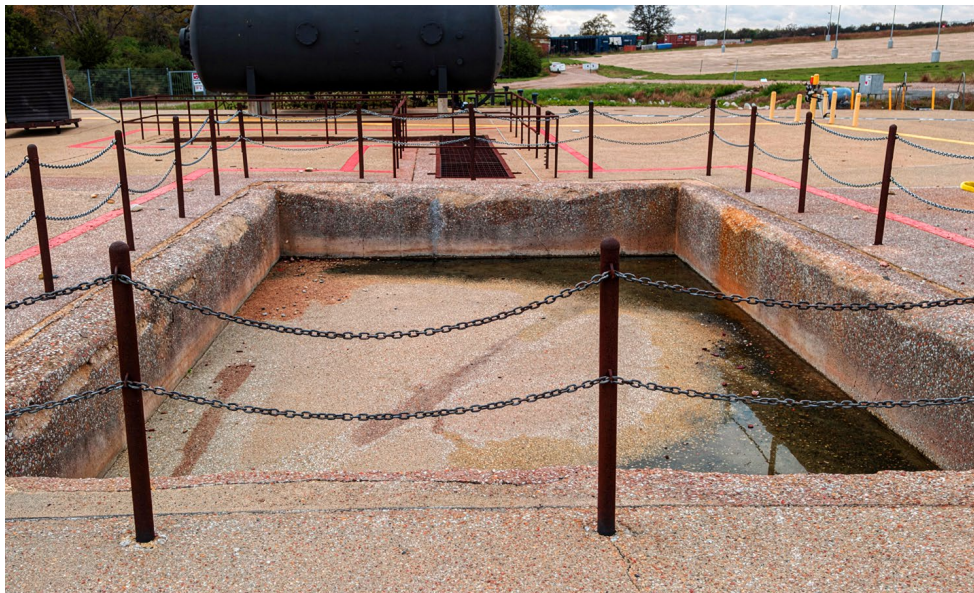
For this testing, the largest impoundment basin by surface area was selected, as shown in Figure 3. The interior dimensions of the basin were 9.91 m (32 ft 6 in.) long by 6.53 m (21 ft 5 in.) wide by 1.22 m (4 ft) deep. The basin was constructed from concrete and reinforcing rebar and included a metal safety fence around the perimeter. The basin contained a further recessed area in the eastmost corner of the pit, with a pipe located inside that can be opened for drainage. During testing, a steel plate with drainage holes was placed over this recessed location to provide a continuous floor for the PFS system to be installed over.

Figure 3. The LNG impoundment.

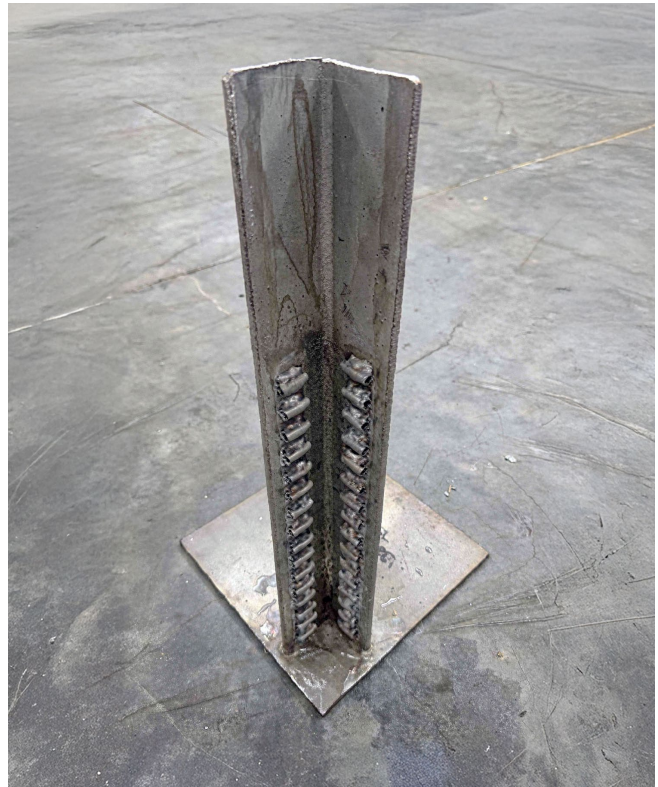
A thermocouple tree was used during testing for the purpose of submerging thermocouples within the LNG at known depths to analyze the burn rate of LNG. The thermocouple tree was constructed using various components of 316 stainless-steel that were MIG welded into a single structure. The components included a 3 in. x 3 in. x 24 in. stainless-steel angle, a 12 in. x 12 in. x 0.25 in. base plate, and 1 in. long sections of 3/8 in. diameter tubing. The pieces of tubing were welded at horizontal orientations along the back of the angle in two vertical columns. The pieces of tubing within each column were spaced at 1 in. intervals, and the left and right columns were staggered 0.5 in. from one another. In total, 32 pieces of horizontal tubing were fixed at 0.5 in. vertical intervals along the back of the structure, as shown in Figure 4. During testing, the thermocouple tree was placed inside the impoundment basin at the northmost corner location so that it would be submerged within the LNG throughout the duration of each burn. Levels were used, and stainless-steel shims were placed underneath the four corners of the baseplate to ensure the structure was properly oriented. With the shims present, the baseplate of the thermocouple tree stood approximately 1.5 in. off the floor of the basin, as shown in Figure 5.

Figure 4. Thermocouple tree: before installation

The 20 sections of high-grade thermocouple wiring were placed through the stainless-steel tubing along the back of the thermocouple tree. The thermocouples were placed at tubing levels 5 through 24 from the bottom of the thermocouple tree, which allowed for data collection between 2.5 in. and 12 in. from the baseplate at  $\frac{1}{2}$  in. intervals. An air set high-temperature cement was applied to the wiring to adhere the thermocouples in place for the duration of testing. The location of each thermocouple was measured and photographed to get an accurate location for use in later analysis.

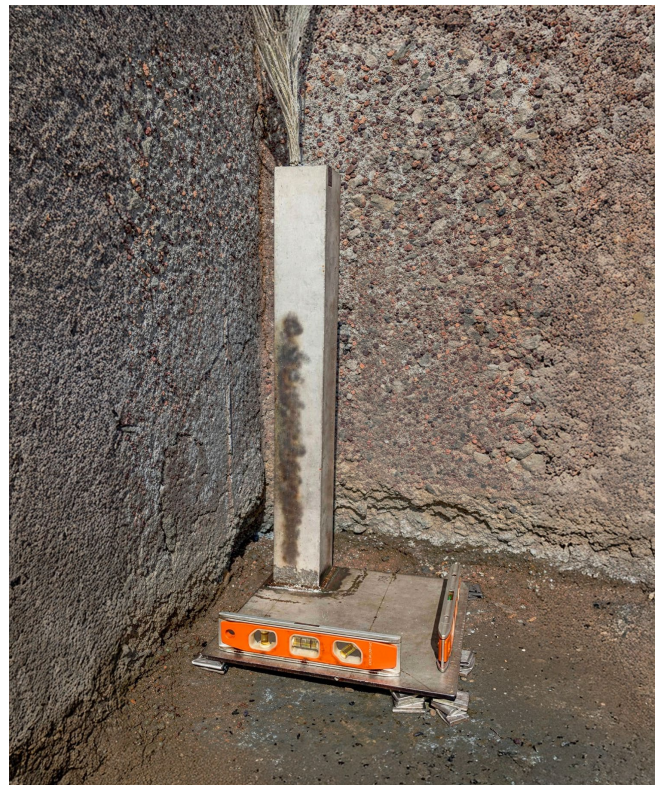
Figure 5. Thermocouple tree: as installed in the impoundment.

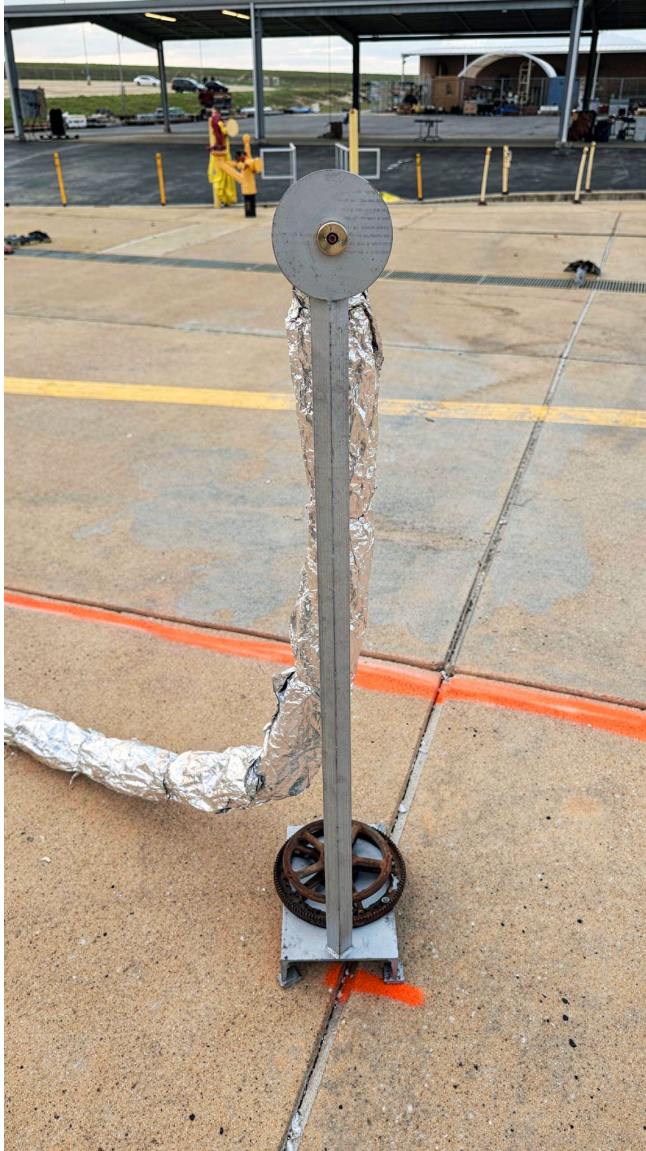
Figure 6. Heat flux sensor prior to the test.

Five heat flux sensors were used during testing to measure the heat flux generated from each LNG burn. Four heat flux sensors used were TG9000-F (120° field of view), manufactured by Vatel Corporation. The fifth heat flux sensor was a GG01-250-SW-05 (180° field of view), manufactured by Hukseflux. All sensors included a sapphire crystal window that allowed radiation to be measured while blocking any convective heat flux from wind. The sensors also featured inlet and outlet connections for active water cooling. Each sensor was mounted to a steel stand which held the device at a height of 1.2 m (4 ft) off the ground at a fixed horizontal angle of 0°, as shown in Figure 6. Omega OM-CP-OCTPRO data loggers were used with each sensor and thermally protected with aluminum shielding and ceramic fiber insulation during testing. Long stretches of rubber tubing were used to provide each sensor with active water cooling from one of the four water sources available. Ceramic fiber insulation and aluminum foil were then wrapped around the rubber tubing and sensor wire to provide additional thermal insulation during the test.

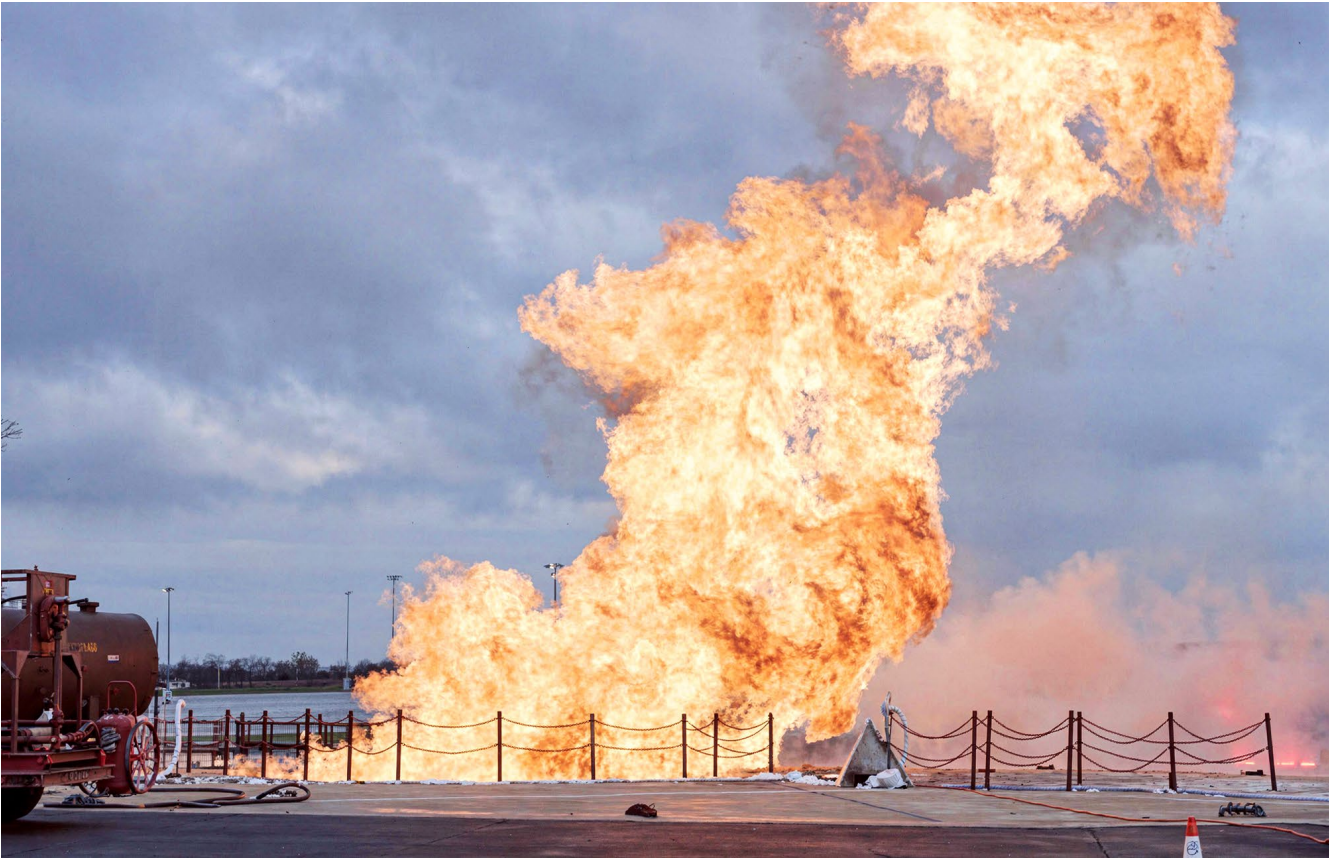
A reference burn was conducted first to gather data from an unmitigated LNG fire scenario. The test began with the discharge of LNG into the impoundment basin. The LNG flow was turned off when a volume of 20.8 m³ (5500 gallons) was achieved, which correlated to a depth of approximately 0.30 m (12 in.). The LNG was ignited and allowed to burn while data was collected. The resulting flame was observed to reach an average length of approximately 23.6 m (77.3 ft) from the opening of the impoundment basin; Figure 8 shows a snapshot of the flame.

Figure 8. Flame during the unmitigated pool fire.

Approximately four minutes into the burn, concrete spalling was observed on the downwind side of the fire along the concrete floor near the basin opening as well as the top of the basin walls. This concrete spalling increased in frequency and severity as the burn continued. After six minutes, the decision was made to extinguish the fire before the original goal of 10 minutes in an effort to preserve the integrity of the basin.

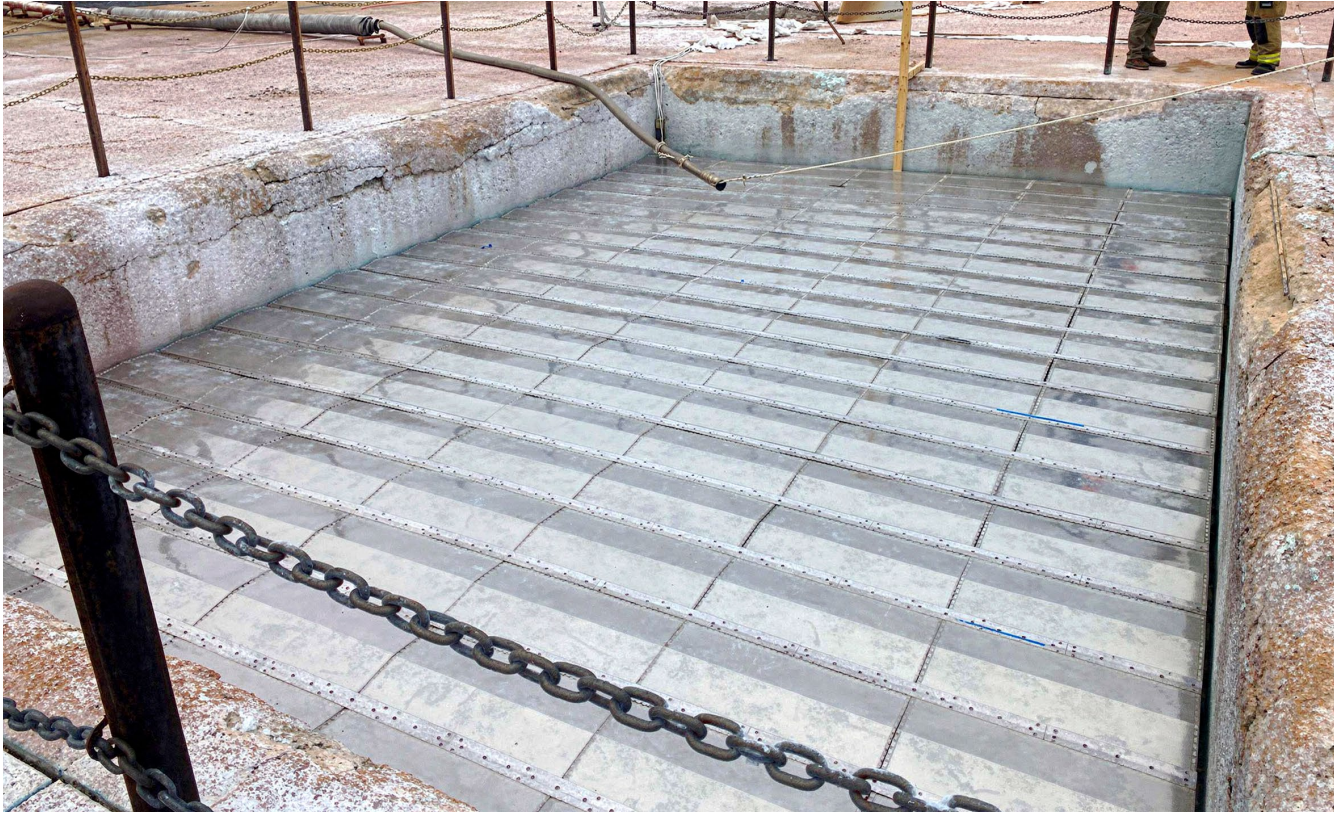
The second burn conducted involved the use of the FOAMGLAS® Pool Fire Suppression™ (PFS) Gen 2 system. The system was assembled into a continuous structure within the impoundment basin using the provided PFS modules, connector bridges, and screws, as shown in Figure 8. The module located near the thermocouple tree had a section measuring 4 in. x 4 in. removed from its corner to ensure the PFS system would not contact the thermocouple tree as it floated on the LNG during testing. A new Vatell TG9000-F heat flux sensor was installed to replace sensor #2 which was lost during the unmitigated burn.

Figure 9. Gen 2 PFS blocks installed in the LNG impoundment.

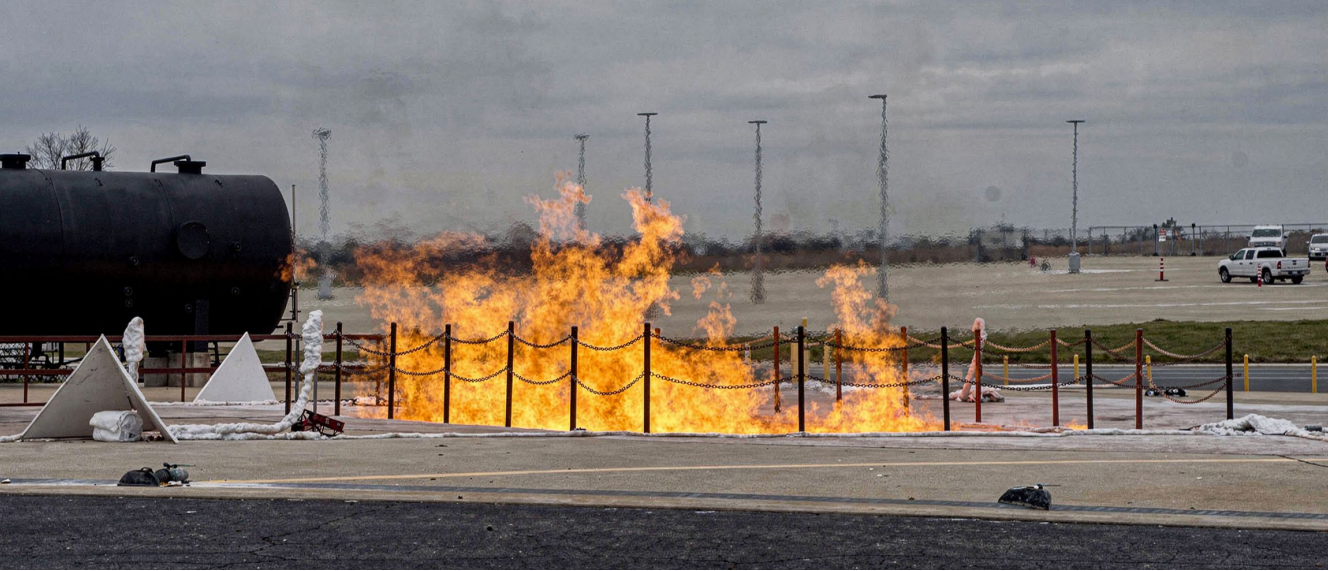
The test began with the same discharge of 20.8 m<sup>3</sup> (5500 gallons) of LNG into the impoundment basin. Note that, due to the displacement of LNG by the PFS system, this volume resulted in a liquid depth of approximately 0.36 m (14 in.). The LNG was ignited and allowed to burn while data was collected. The resulting flame was observed to be much smaller than the unmitigated burn, reaching a length of approximately 2.9 m (9.6 ft) from the basin opening, as shown in Figure 10. The radiant heat escaping the fire was also noted to be significantly less than that of the unmitigated burn. The concrete spalling that was observed near the basin opening during the unmitigated test was not observed during this burn.

Figure 10. Flame during the PFS-mitigated test.
