# CONSTRUCTING A CERTIFIED NET-ZERO HOME

**Builder Success Story**  
Cedarglen Homes

## CASE STUDY SCOPE

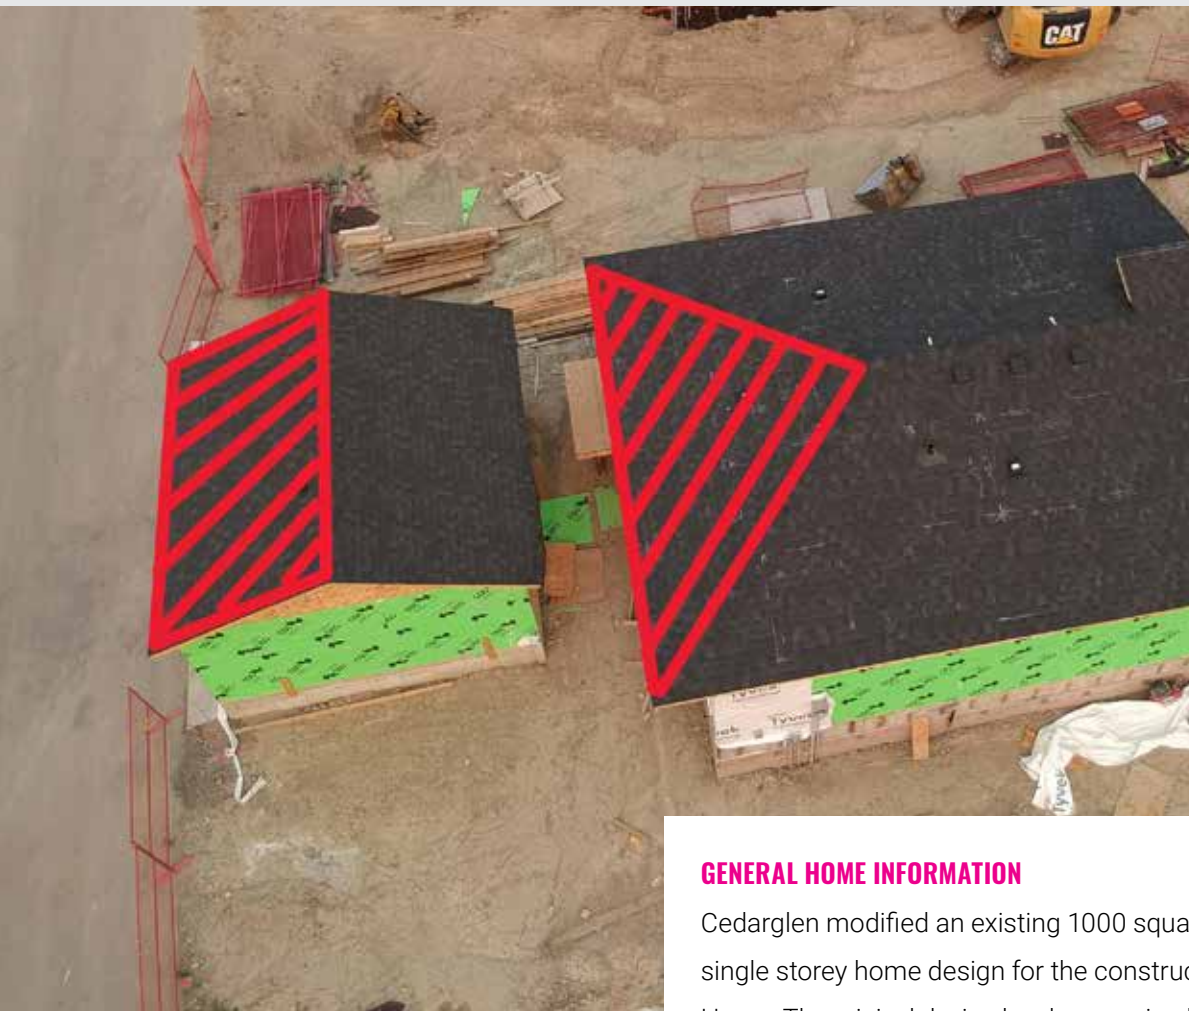
**Figure 1:** Aerial view of the Net-Zero Home, illustrating limited south-facing roof-space for solar system installation. Source: Cedarglen Homes

The bungalow with detached garage resides in central-north Calgary community of Livingston bordering the city's edge. The home is oriented with the front door facing directly north. This site was intentionally selected as it presents non-ideal conditions for solar energy generation which typically reduce the Net-Zero potential of a home. In Canada, the sun resides to the south so to achieve optimal solar-gains, the largest area of roof-space should be oriented south. With this in mind, one of the key goals of this case study was to demonstrate that a high efficiency, or in this case Net-Zero, home can be achieved on a less-than-ideal site.

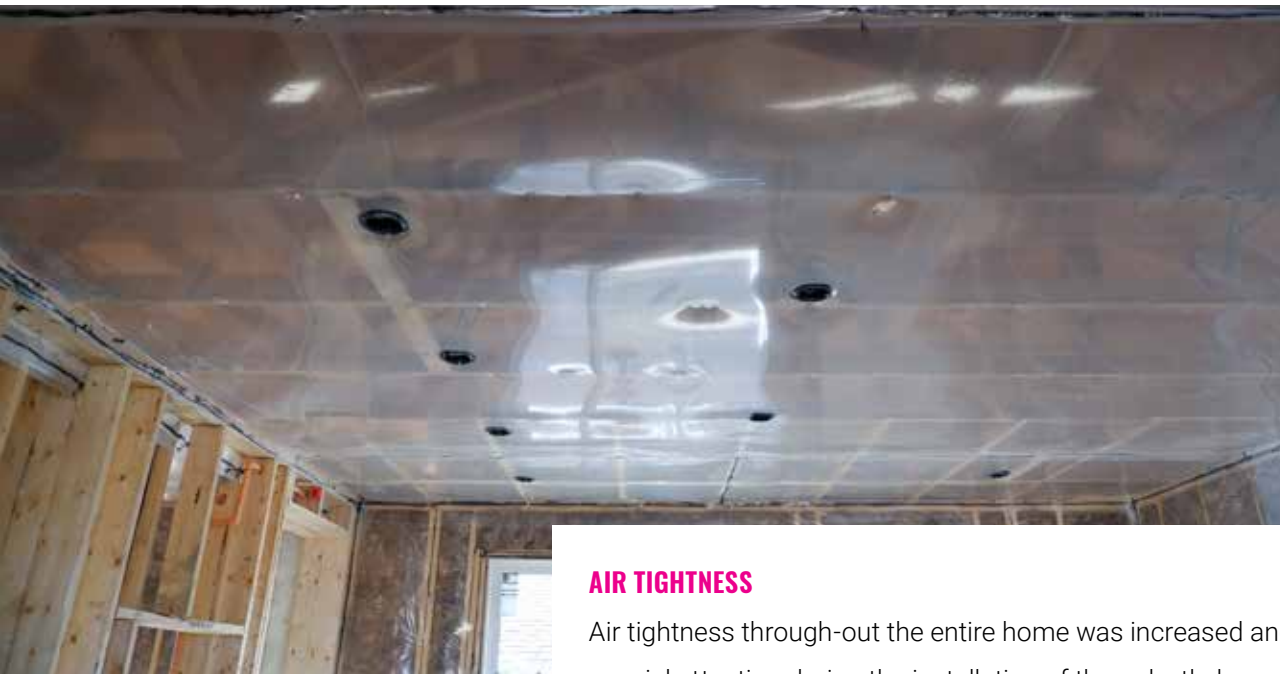
**Figure 3:** Photo of living room ceiling with pot-lighting taken during blower door test 1.  
Source: primary

Air tightness through-out the entire home was increased and given special attention during the installation of the polyethylene vapour barrier. Figure 3 demonstrates the air-sealing of the pot-light system in the living room. This photo was taken during the first blower door test, performed prior to the installation of gypsum and finishes. The second blower door test was performed upon completion of the home.

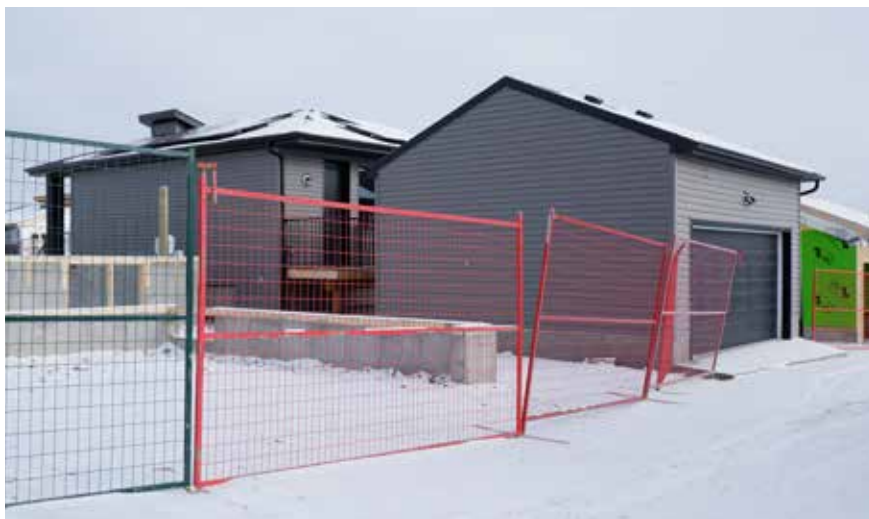
**Figure 5:** Photo of home from the side with view of solar array on roof. Source: primary.

Electrical HVAC units were selected for the project. Despite being located on a site with a non-optimal solar orientation, the home's solar array has a total rated capacity of 10.8 kW. The system was designed with thirty solar photovoltaic (PV) panels. Six panels are located on the south-facing slope of the roof, fourteen on the east, and ten on the west. A solar inverter/generator of 7.6 kW size has been installed along side the solar array. No solar was installed on the detached garage unit.

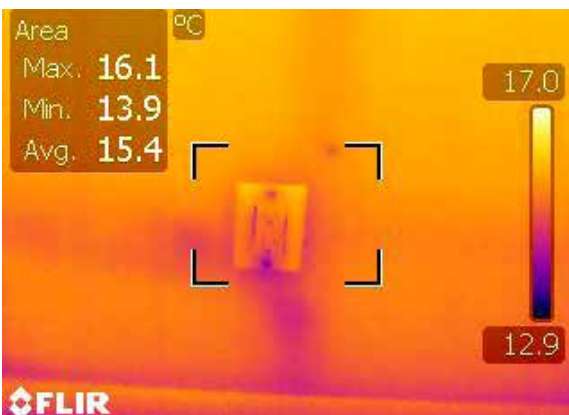
**Figure 8:** Minimal thermal penetration observed from framing surrounding an electrical fixture.  
Source: SAIT

**More minor thermal penetrations** were observed at certain sections of the main-level exterior wall, such as where more framing was present around electrical fixtures. Overall, the home was observed as above average with fewer thermal penetrations than typical homes of similar size.

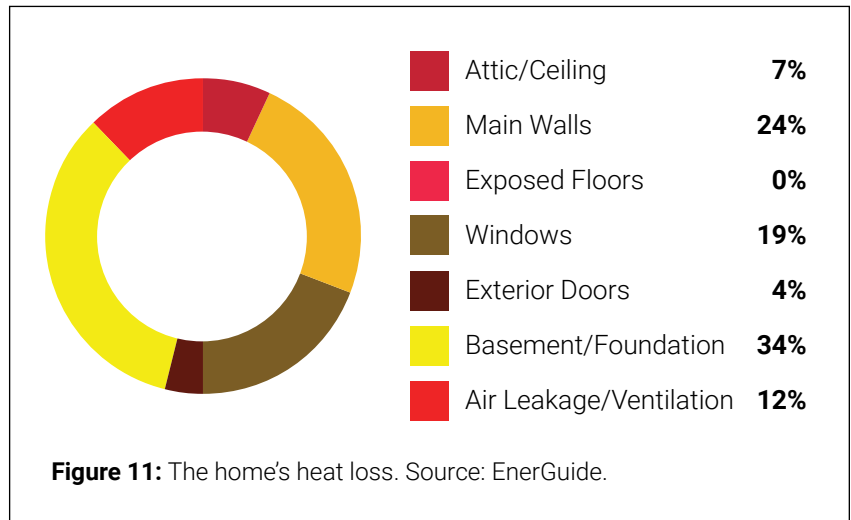
On December 9th, 2021, the home received an EnerGuide rating of 0, indicating that it generates as much energy as it consumes on an annual basis. Its rating intensity was reported as 0.22 GJ/m<sup>2</sup>/yr. Figures 10 and 11 illustrate the home's energy usage and heat loss:

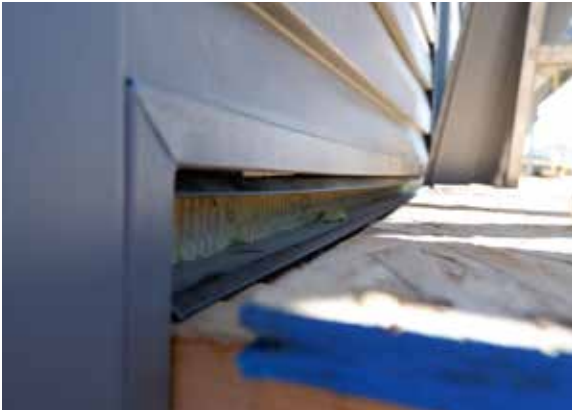
**Figure 12:** Photo of double flashing and insulation detailing around attached deck at rear of home.  
Source: SAIT

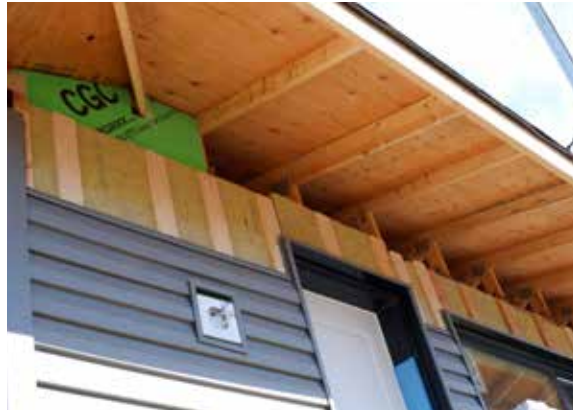
**Figure 13:** Photo of exterior 51 mm (2') Thermafiber® RainBarrier® ci High Compressive Plus (110) Mineral Wool Insulation and strapping below vinyl cladding.  
Source: SAIT

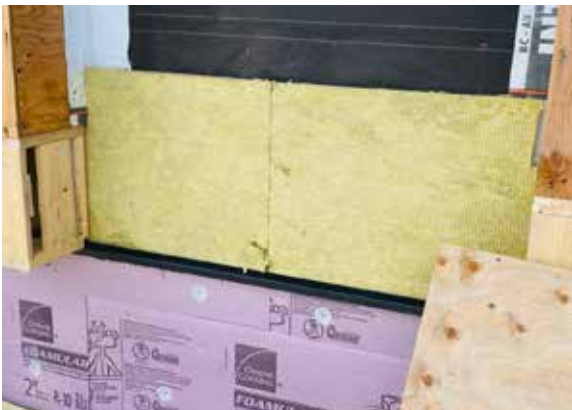
**Figure 14:** Below-grade to above grade wall transition showcasing 51 mm (2') Thermafiber® RainBarrier® ci High Compressive Plus (110) Mineral Wool Insulation and 51 mm (2') FOAMULAR® C-300 Extruded Polystyrene Rigid Insulation.  
Source: SAIT

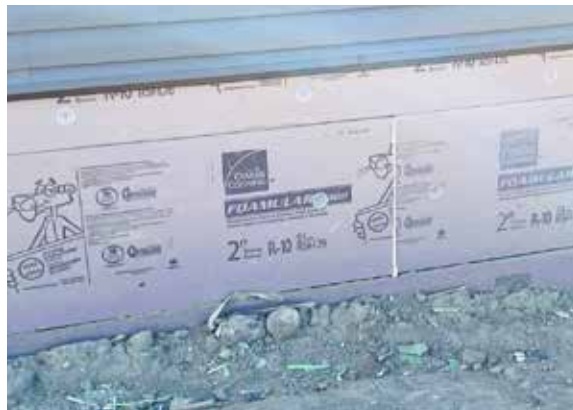
**Figure 15:** Below-grade exterior insulation showcasing 51 mm (2') FOAMULAR® C-300 Extruded Polystyrene Rigid Insulation.  
Source: SAIT
